APPENDICES – ACTION PLAN

Implementation Framework

Appendices A through I provide a description of needs and recommended transportation investments at each school location. These recommendations reflect the community engagement and technical analysis that occurred throughout the 9-month study process. Recommendations include a project description and location. The proposed implementation timeline reflects the estimated complexity and cost of the project and is described as short (less than 2 years), mid (2–5 years) or long (over 5 years) term. The estimated rough order of magnitude cost is reflected in dollar signs, with one symbol representing a projected cost less than \$100,000, two symbols representing \$100,000–\$500,000, and three symbols representing project costs expected to be greater than \$500,000. The priority of the project is reflected as high, medium, or low, with the most urgent needs as assessed by the project team designated as high priority.

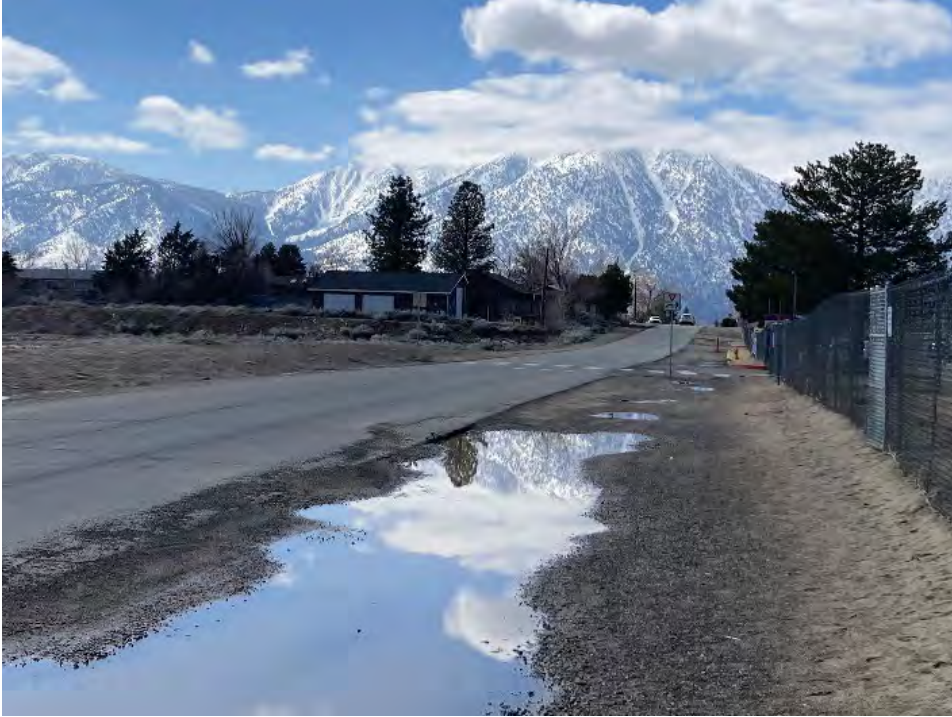
Existing conditions along Muir Drive

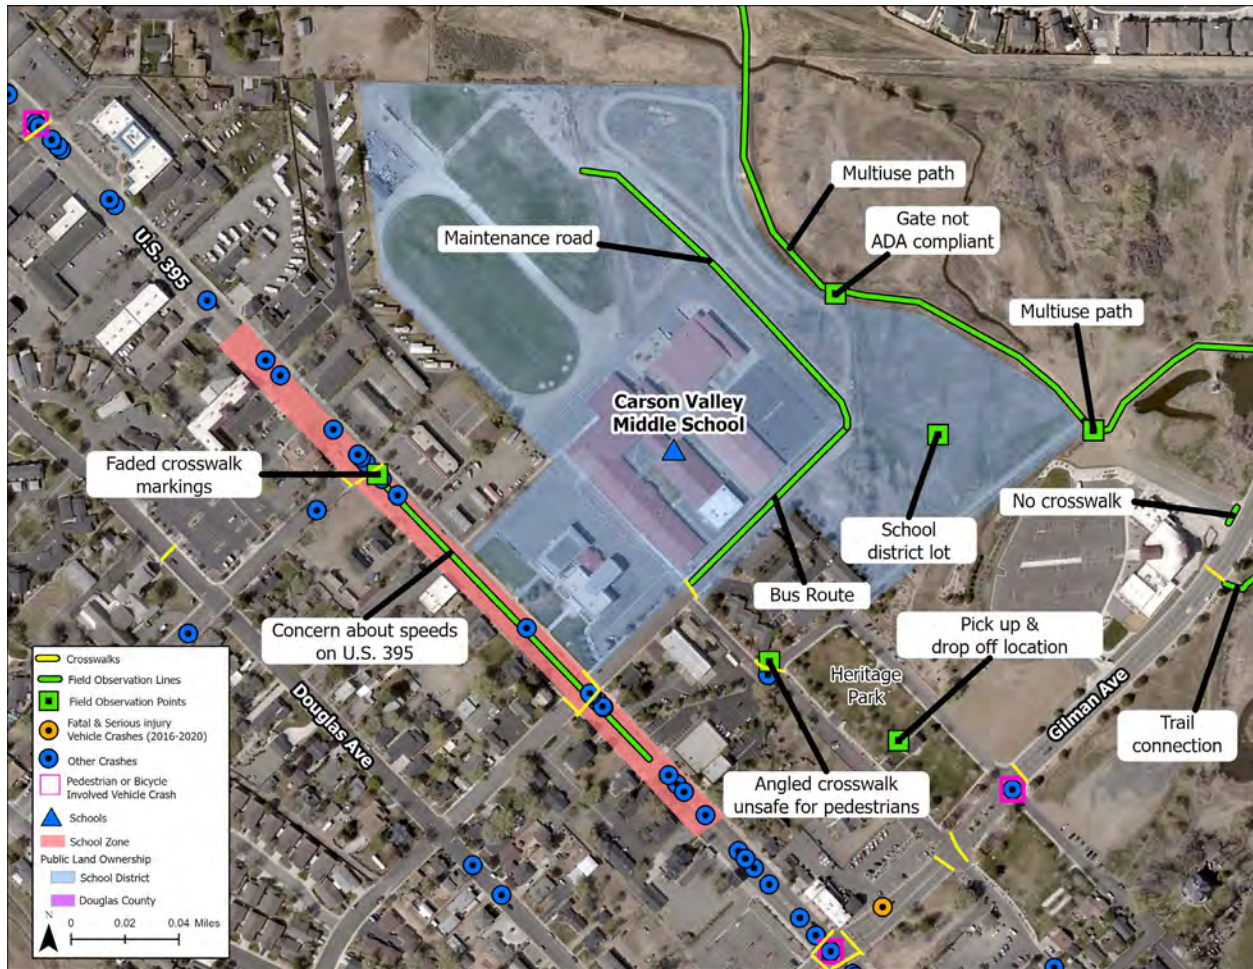
Exhibit B-1: Carson Valley Middle School Existing Conditions

Exhibit B-1 below provides a summary of the safety, intersection, access and circulation, and infrastructure condition issues surrounding Carson Valley Middle School.

- Gate to access multiuse path is not ADA compliant.
- Missing crosswalk at side access point.
- Angled crosswalk just east of school location is unsafe for pedestrians.
- High speeds along US 395 (in front of the school) are unsafe for pedestrians, especially children.
- RRFBs along US 395 do not meet multilane highway specifications.
- There is no school zone signage along High School Street and Courthouse Street.
- There is a sight line issue near Courthouse Street and Slaughterhouse Lane due to overgrown vegetation.

- Faded crosswalk with low visibility at the intersection of US 395 and Mill Street.
- High truck volumes along US 395, creating potential safety issues for pedestrians at Mill Street and High School Street intersections.
- Angled pedestrian crossing at the Slaughterhouse Lane and Courthouse Street intersection is unsafe, especially for children.

- High School Street is congested during school pick-up and drop-off times.
- Parents have been observed cutting through the NAPA Auto Parts parking lot to pick up/drop off students due to congestion on High School Street.
- Driveway radius out of school parking lot is too small to properly accommodate buses.
- There is some confusion among drivers at the intersection of Courthouse Street and the school entrance/exit.

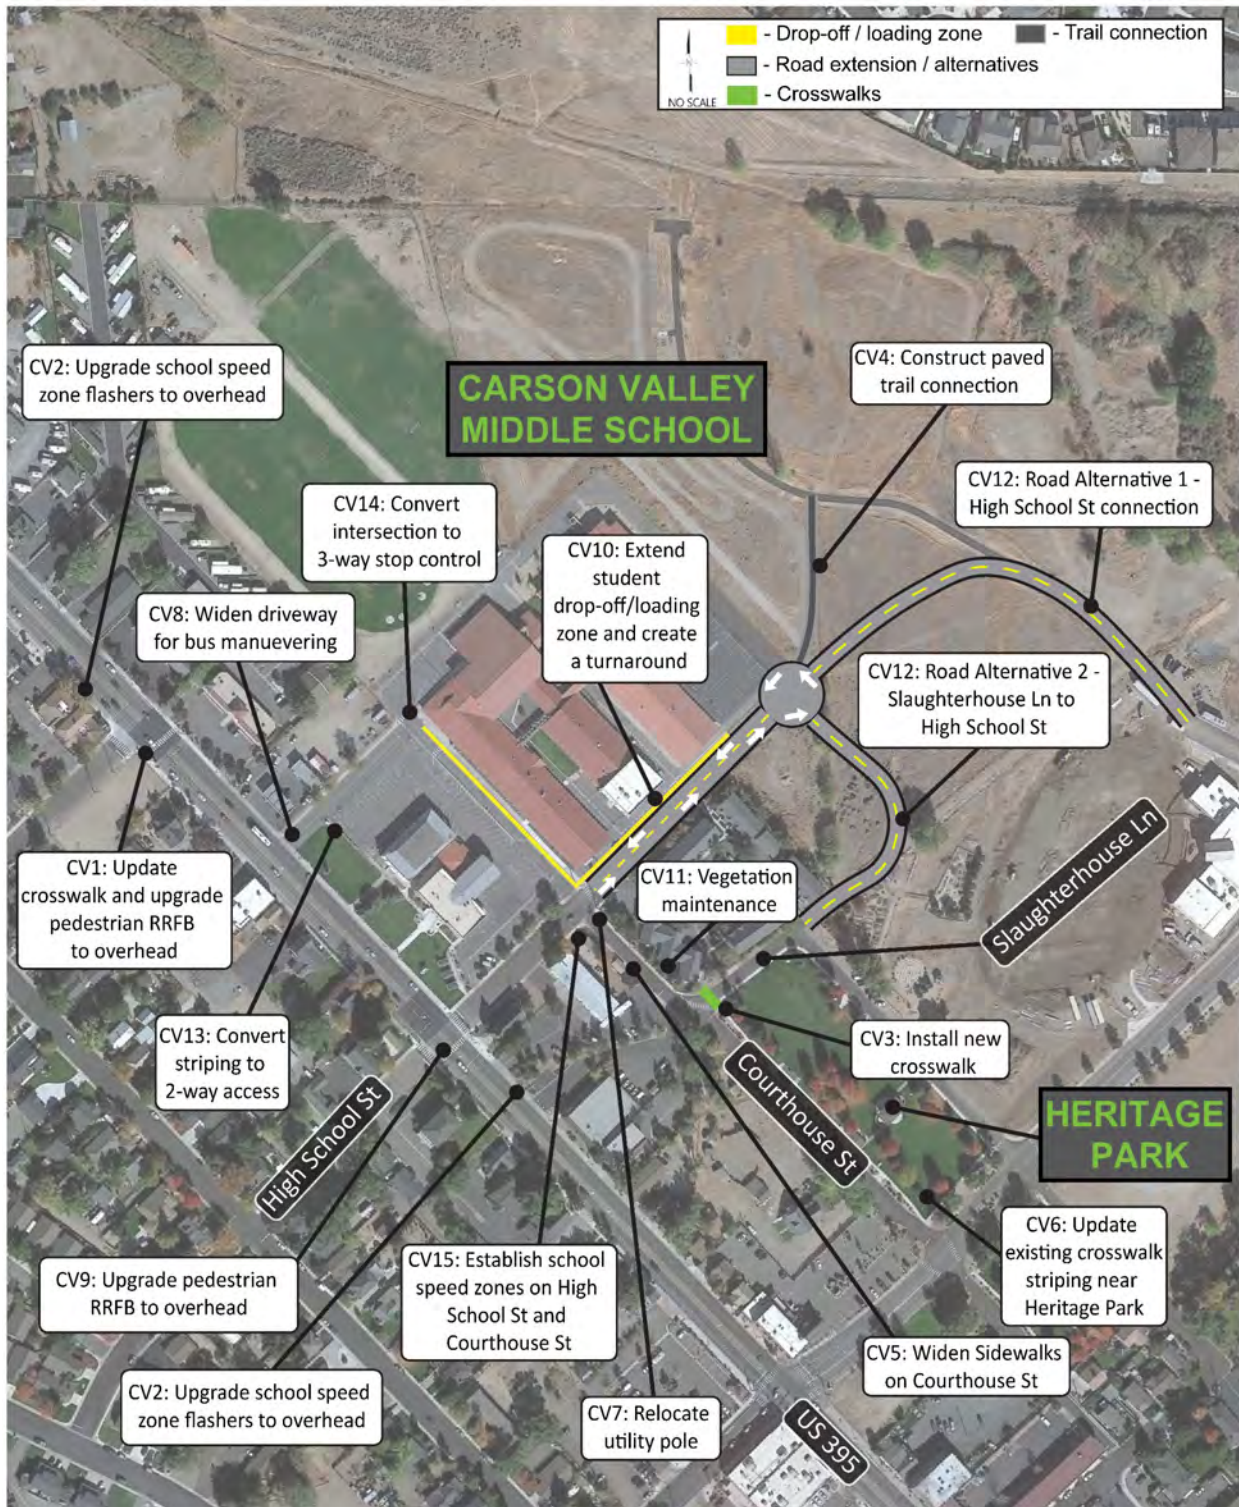
Exhibit B-2: Carson Valley Middle School Recommended Improvements

Improvements to help alleviate access, circulation, and infrastructure issues/deficiencies found at Carson Valley Middle School are outlined in **Table B-1** and shown in **Exhibit B-2**.

ID	Implementation Timeline	Priority	Location	Draft Recommendations	Cost Estimate
CV1	Short	High	US 395/Mill Street intersection	Restripe crosswalk pavement markings for high visibility and upgrade crossing to an overhead mast arm RRFB per NDOT standards.	\$\$\$
CV2	Short	High	US 395 within school zone	Install school zone limits signage. Upgrade school flashers to overhead mast arm.	\$
CV3	Mid	High	Slaughterhouse Lane/Courthouse Street intersection	Install high visibility crosswalk perpendicular across Slaughterhouse Lane. Connect the existing sidewalk to the new landing point on the north corner. Install ADA curb ramp.	\$\$
CV4	Mid	High	East corner of the school by the	Pave a connection from the back of the school to the existing multiuse path.	\$-\$\$

ID	Implementation Timeline	Priority	Location	Draft Recommendations	Cost Estimate
			playground to the multiuse path		
CV5	Mid	Medium	Courthouse Lane, from Slaughterhouse Lane to High School Street	Widen sidewalks.	\$\$
CV6	Short	High	Throughout the Heritage Park parking lot	Restripe crosswalk pavement markings for high visibility.	\$
CV7	Long	High	High School Street and Courthouse Street, northeast corner	Relocate utility pole that is located in the sidewalk and blocks access to the curb ramp.	\$\$\$
CV8	Mid	Medium	Main school entrance on US 395	Widen driveway for bus maneuvering.	\$\$
CV9	Mid	High	US 395/High School Street intersection	Upgrade crossing to an overhead mast arm RRFB per NDOT standards.	\$\$\$
CV10	Mid	Medium	High School Street east of Courthouse Street	Extend drop-off/loading zone to northeast corner of school. Create a turnaround area at the end of High School Street.	\$-\$\$
CV11	Short	Medium	West side of Slaughterhouse Lane and north side of Courthouse Street	Maintain vegetation along sidewalks.	\$

ID	Implementation Timeline	Priority	Location	Draft Recommendations	Cost Estimate
CV15	Short	High	On High School Street and Courthouse Street	Establish school speed zones.	\$

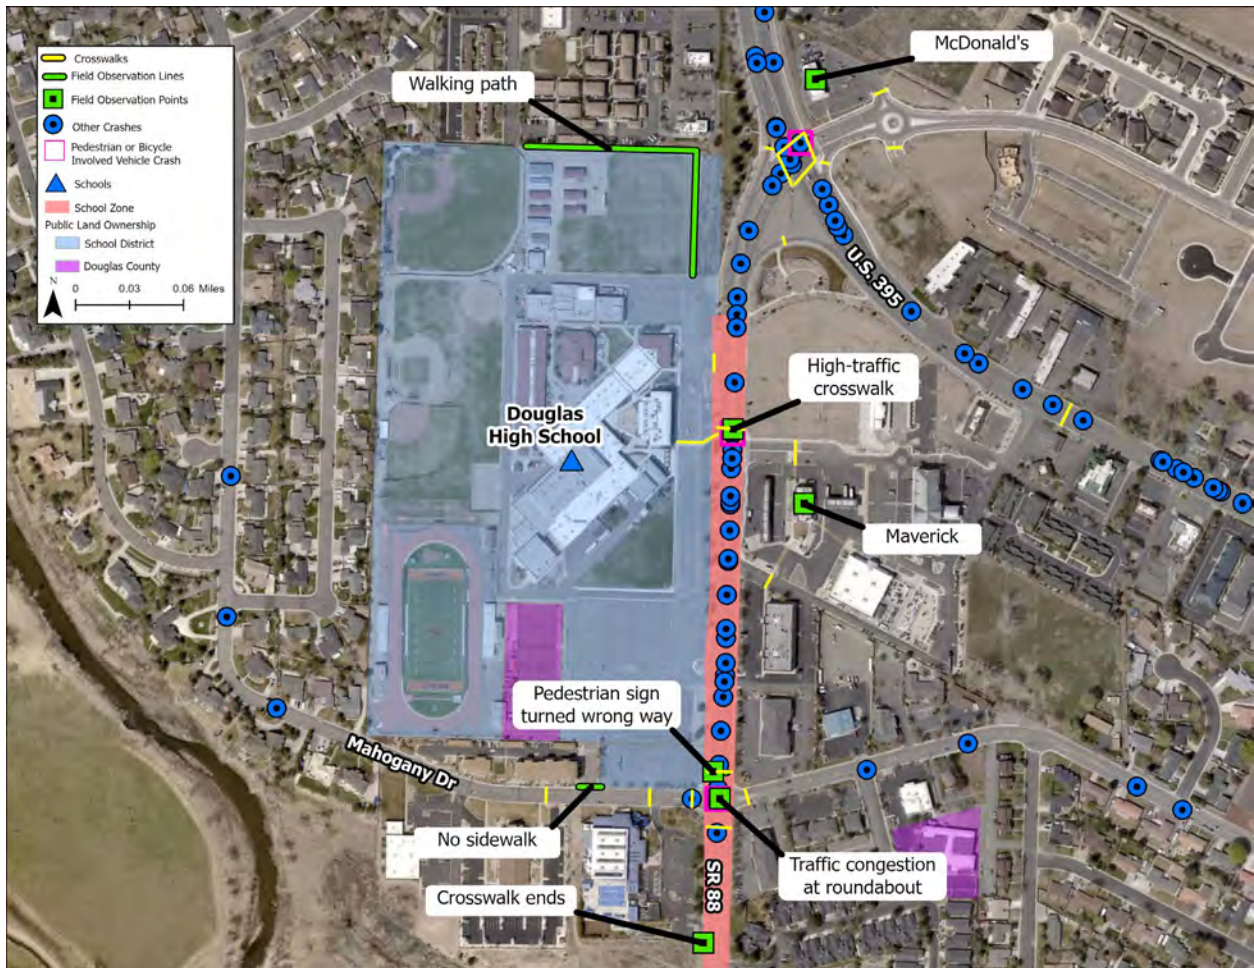
Exhibit C-1: Douglas High School Existing Conditions

Exhibit C-1 below provides a summary of the safety, intersection, access and circulation, and infrastructure condition issues surrounding Douglas High School.

- An incomplete crosswalk south of the school along SR 88.
- A missing segment of sidewalk along Mahogany Drive just south of the school.
- A pedestrian sign along SR 88 was facing the wrong direction.

- Unsafe and long-distance pedestrian crossing at the SR 88/Maverik driveway intersection.
- Faded crosswalks and improperly oriented signage at the SR 88/Mahogany Drive/County Road roundabout.
- Unsafe left-turn movements to/from school parking, especially during pick-up and drop-off times.

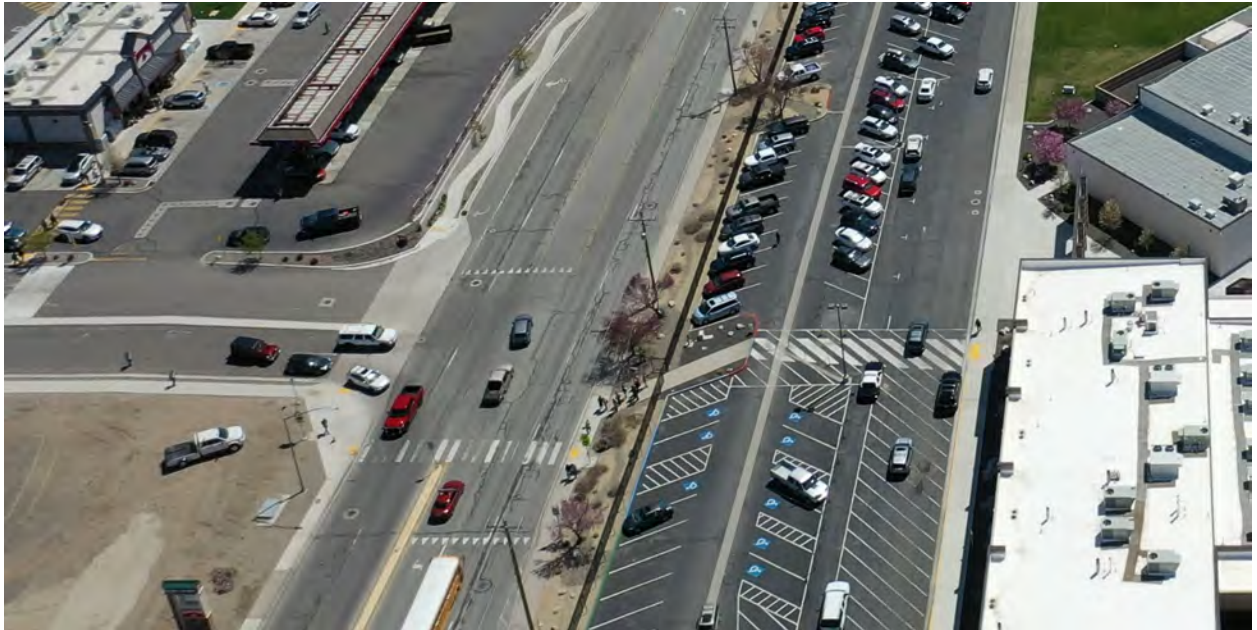
The crosswalk from Douglas High School to the Maverick driveway on SR 88 (visualized on the following page) was identified as a priority due to the high volume of students crossing at this location and the high truck volumes on SR 88. The current crosswalk location traverses the center left turn lane used to access the Maverick driveway. The current crossing provides a street-level pedestrian-activated RRFB. Concept DH2 in **Table C-1** of the Action Plan proposes relocating the crosswalk to the opposite side of the driveway. By moving the crosswalk out of the center turn lane, it provides room for a center island that functions as a pedestrian refuge and offers enhanced visibility for pedestrians. Overhead RRFBs are recommended due to high traffic and truck volumes at this location.

Existing crosswalk along SR 88 near Douglas High School

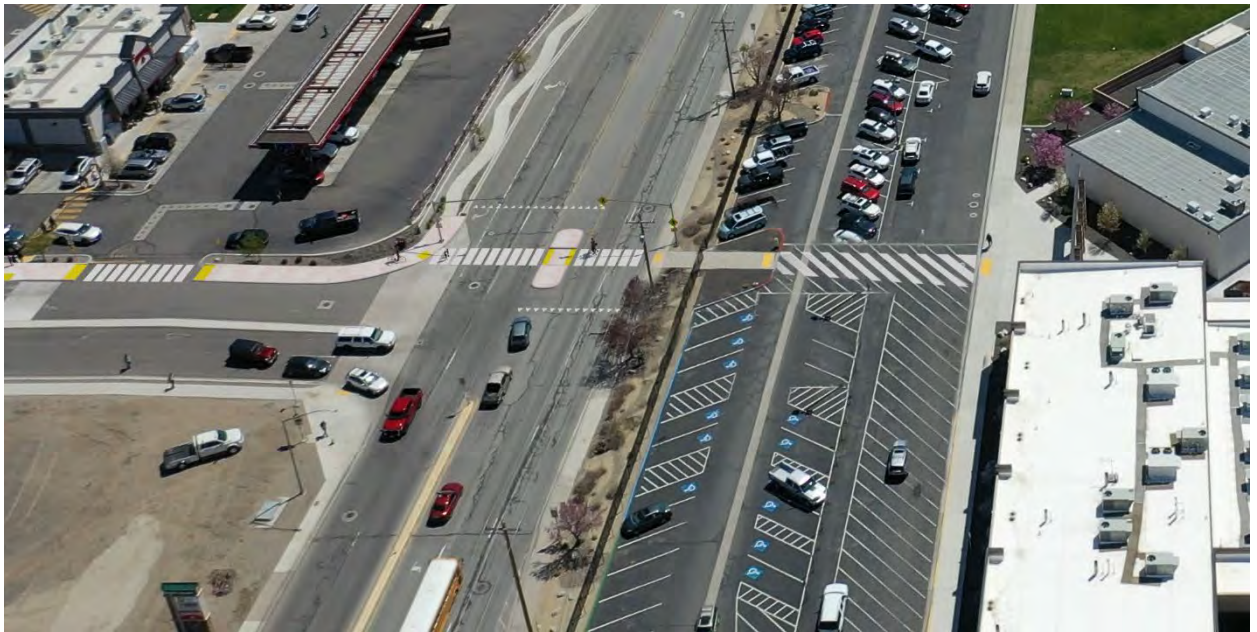
Proposed crosswalk improvements along SR 88 near Douglas High School

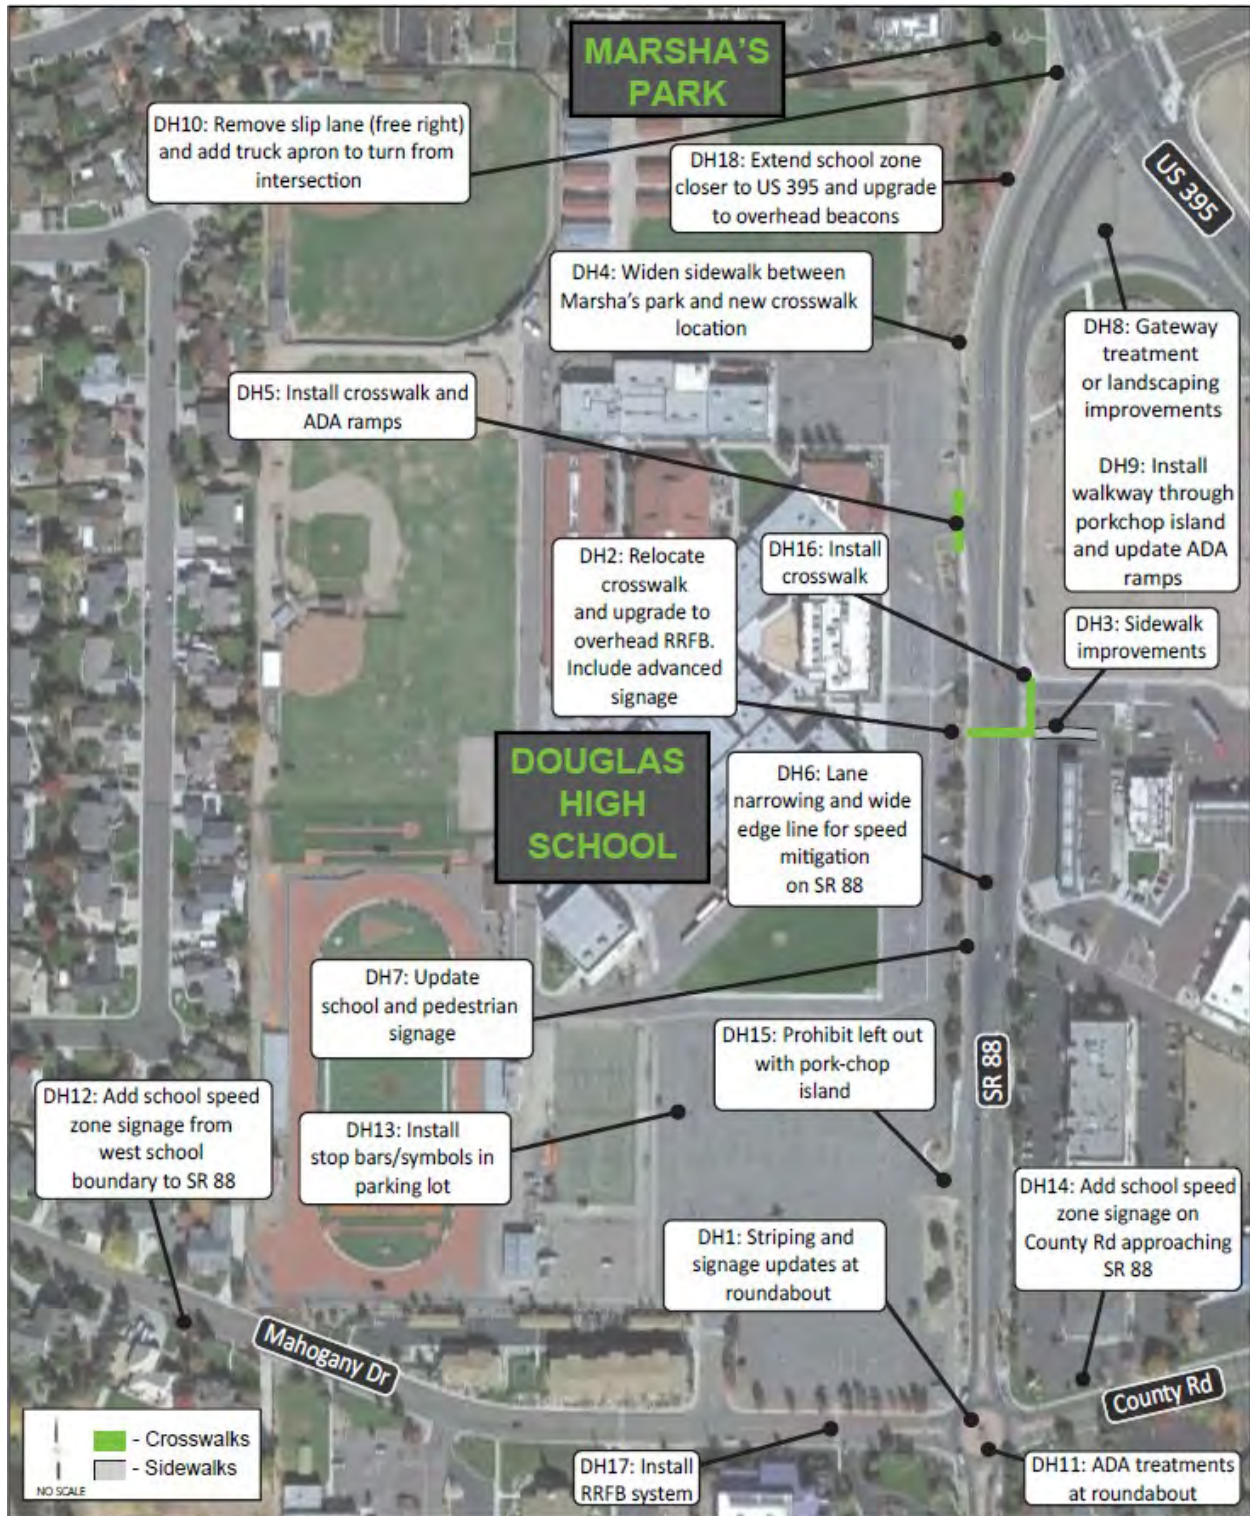
Exhibit C-2: Douglas High School Recommended Improvements

Improvements to help alleviate access, circulation, and infrastructure issues/deficiencies found at Douglas High School are outlined in **Table C-1** and shown in **Exhibit C-2**.

ID	Implementation Timeline	Priority	Location	Draft Recommendations	Cost Estimate
DH1	Short	High	SR 88/Mahogany Drive/County Road Roundabout	Restripe all crosswalks. Reorient signage at the roundabout that was damaged during the snowstorm.	\$
DH2	Mid	High	SR 88/Maverik driveway intersection	Relocate existing crosswalk to the south side of the intersection. Install a pedestrian refuge island. Install an overhead mast arm RRFB.	\$\$
DH3	Mid	High	SR 88/Maverik driveway intersection	Continue sidewalk on the south side of the Maverik roadway to provide pedestrian access to Maverik.	\$\$
DH4	Long	Medium	SR 88 along school frontage from Marsha's Park (US 395/SR 88) to the relocated crossing by Maverik	Widen sidewalks.	\$\$\$
DH5	Mid	High	SR 88 along school frontage from Marsha's Park (US 395/SR 88) to the relocated crossing by Maverik	Install high visibility crosswalks with ADA ramps.	\$\$
DH6	Mid	Medium	SR 88 from US 395 to the Mahogany roundabout	Narrow travel lanes to 10.5-11' in collaboration with Nevada DOT. Paint a wide edge line to visually reduce travel way. Evaluate widening sidewalk if there is enough ROW.	\$\$-\$\$\$

DH7	Short	High	School zone	Replace existing school zone and pedestrian signage with fluorescent signage.	\$
DH8	Mid	Low	Porkchop island on the south side of the US 395/SR 88 intersection	Evaluate gateway treatment or low-height landscaping that still provides visibility.	\$\$-\$\$
DH9	Mid	Medium	Porkchop island on the south side of the US 395/SR 88 intersection	Install a through walkway with ADA ramps from the intersection crosswalks to the crosswalk across the slip lane.	\$\$

ID	Implementation Timeline	Priority	Location	Draft Recommendations	Cost Estimate
DH10	Mid	Medium	Slip lane from southbound US 395 to southbound SR 88	Remove slip lane and add truck aprons to allow right turn from the intersection. Alternatively, reduce slip lane width and add truck aprons. Collaborate with NDOT.	\$\$\$
DH11	Short	High	Mahogany Drive/ County Road/SR 88	Install ADA detectable warning surfaces at the roundabout medians.	\$
DH12	Short	High	West of SR 88/ Mahogany Drive/ County Road Roundabout	Install school speed zone sign on Mahogany Drive approaching SR 88.	\$
DH13	Short	High	School parking lot	Install traffic control pavement markings: stop bars/signs and pedestrian crosswalks.	\$
DH14	Short	High	East of SR 88/ Mahogany Drive/ County Road Roundabout	Install school speed zone sign on County Road approaching SR 88.	\$
DH15	Mid	Medium	School driveway entrance: north of SR 88/Mahogany Drive/County Road roundabout	Prohibit left turns out of the school driveway using signage or a porkchop island.	\$-\$\$

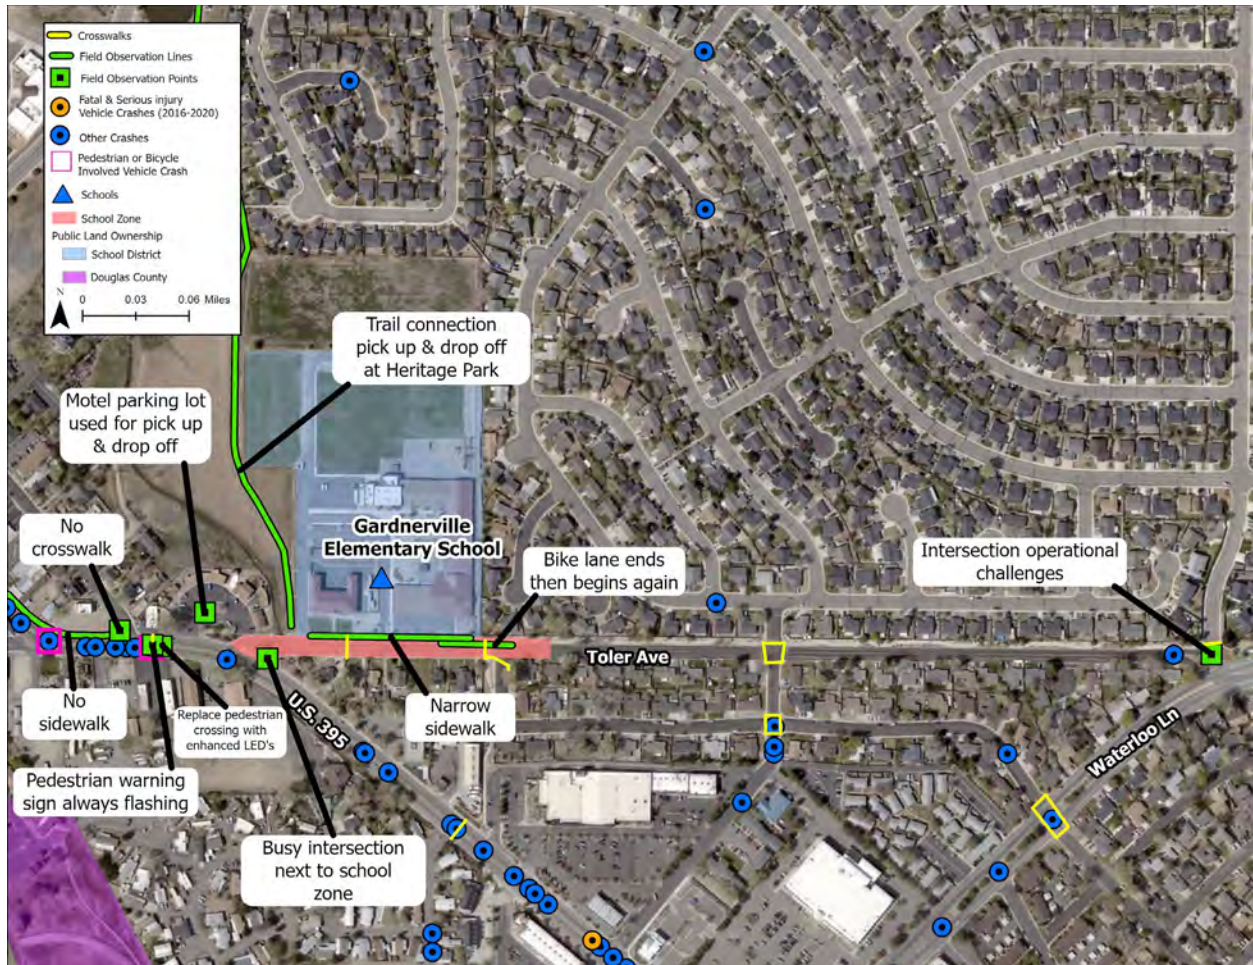
Exhibit D-1: Gardnerville Elementary School Existing Conditions

Exhibit D-1 below provides a summary of the safety, intersection, access and circulation, and infrastructure condition issues surrounding Gardnerville Elementary School.

- Missing crosswalk at US 395 and Mission Street.
- Missing sidewalk on the north side of US 395 just south of Mission Street.
- Pedestrian warning sign near US 395 and Mission Street was always flashing, which could eventually cause drivers to begin ignoring the warning. This sign could potentially be replaced with enhanced LEDs.
- Sidewalks along Toler Avenue south of the school are too narrow.
- Bike lane along Toler Avenue south of the school is not continuous.
- The bike lane along Toler Avenue is cut off by a bulb-out designed to shorten the crossing distance for students, just east of the school.

- The intersection of Toler Avenue, Waterloo Lane, and Harvest Avenue is challenging to navigate due to its configuration.
- The intersection of Toler Avenue and US 395 is very busy and located immediately adjacent to the school property. The left-turn movement from southbound US 395 to Toler Avenue needs assessment to ensure safe and efficient traffic flow in the vicinity of the school.
- Outdated continuously flashing crosswalk beacon and sidewalk gaps at the intersection of US 395 and Mission Street.
- Unsafe and outdated crosswalk at the intersection of US 395 and Kingslane Court.
- High truck volumes at intersections along US 395.

- Many left turns were observed at the intersection of US 395 and Toler Avenue. These unprotected lefts are one of the riskier types of turning maneuvers.
- Parents have been observed picking up and dropping off students behind the school, off N Marion Russell Drive, with the potential for pedestrian-vehicle conflicts.
- Conflicts and potential conflicts were observed in the informal parking area behind the school, off Giles Lane.

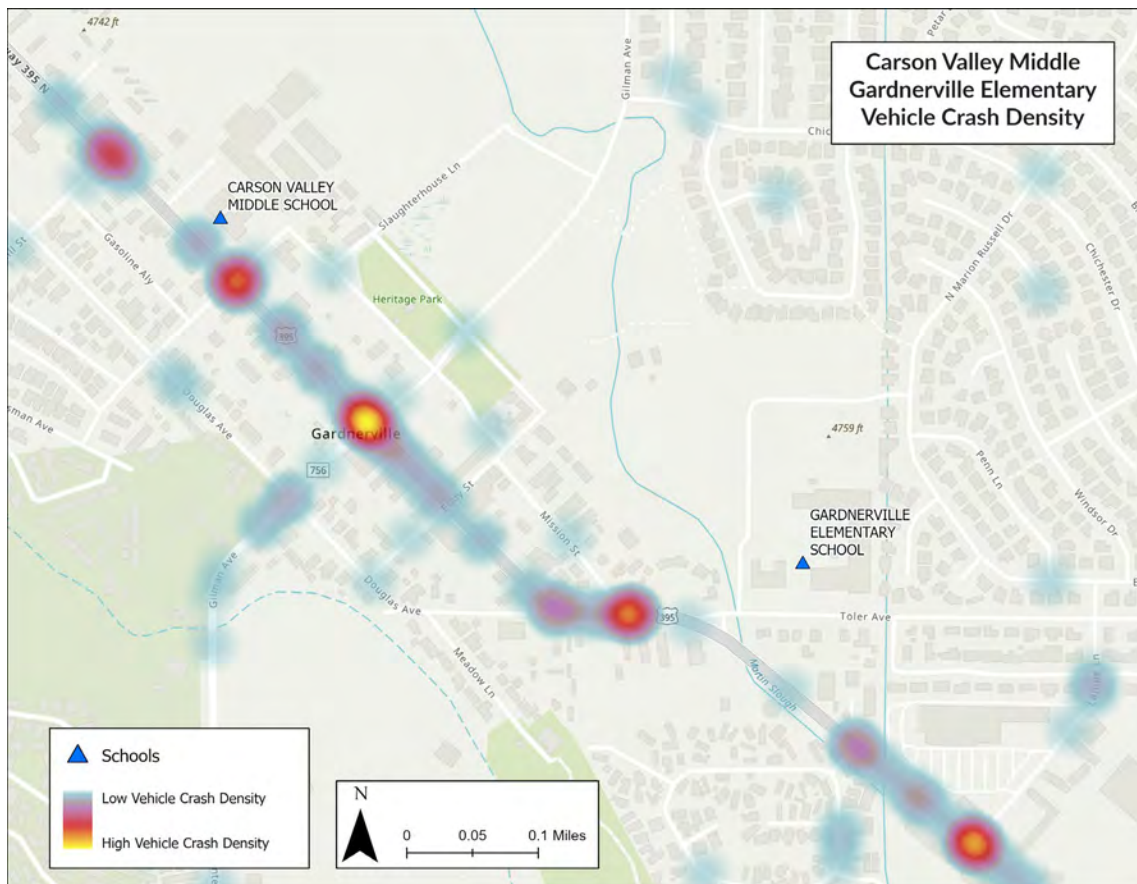
Exhibit D-2: Gardnerville Elementary School Area Crashes, 2016-2020

The total number of crashes observed in the area is higher than around some of the other schools in Douglas County due to its proximity to US 395. A total of 447 crashes occurred within two miles of the school, including three fatal and three serious injury crashes. Thirty-four percent of crashes were rear-end collisions and 27% were angle crashes.

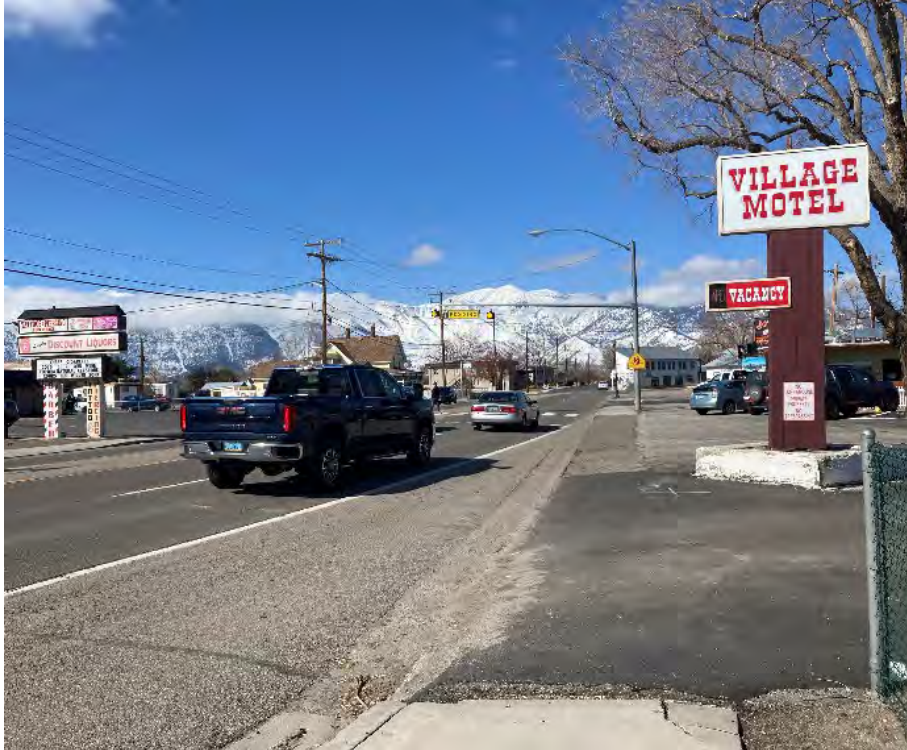
Existing conditions along US 395

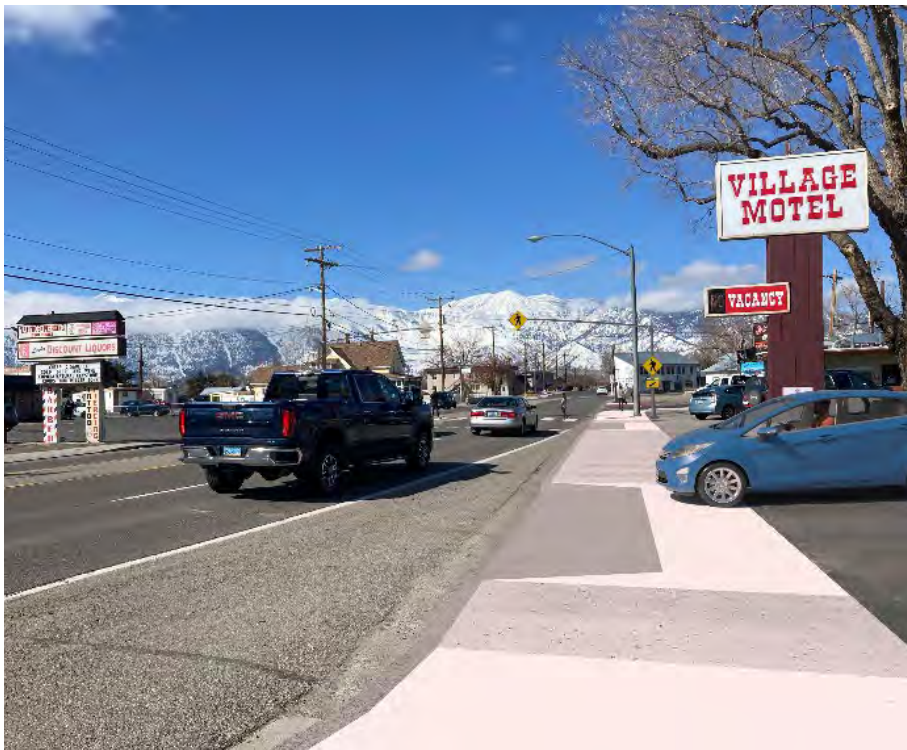
US 395 with proposed improvements

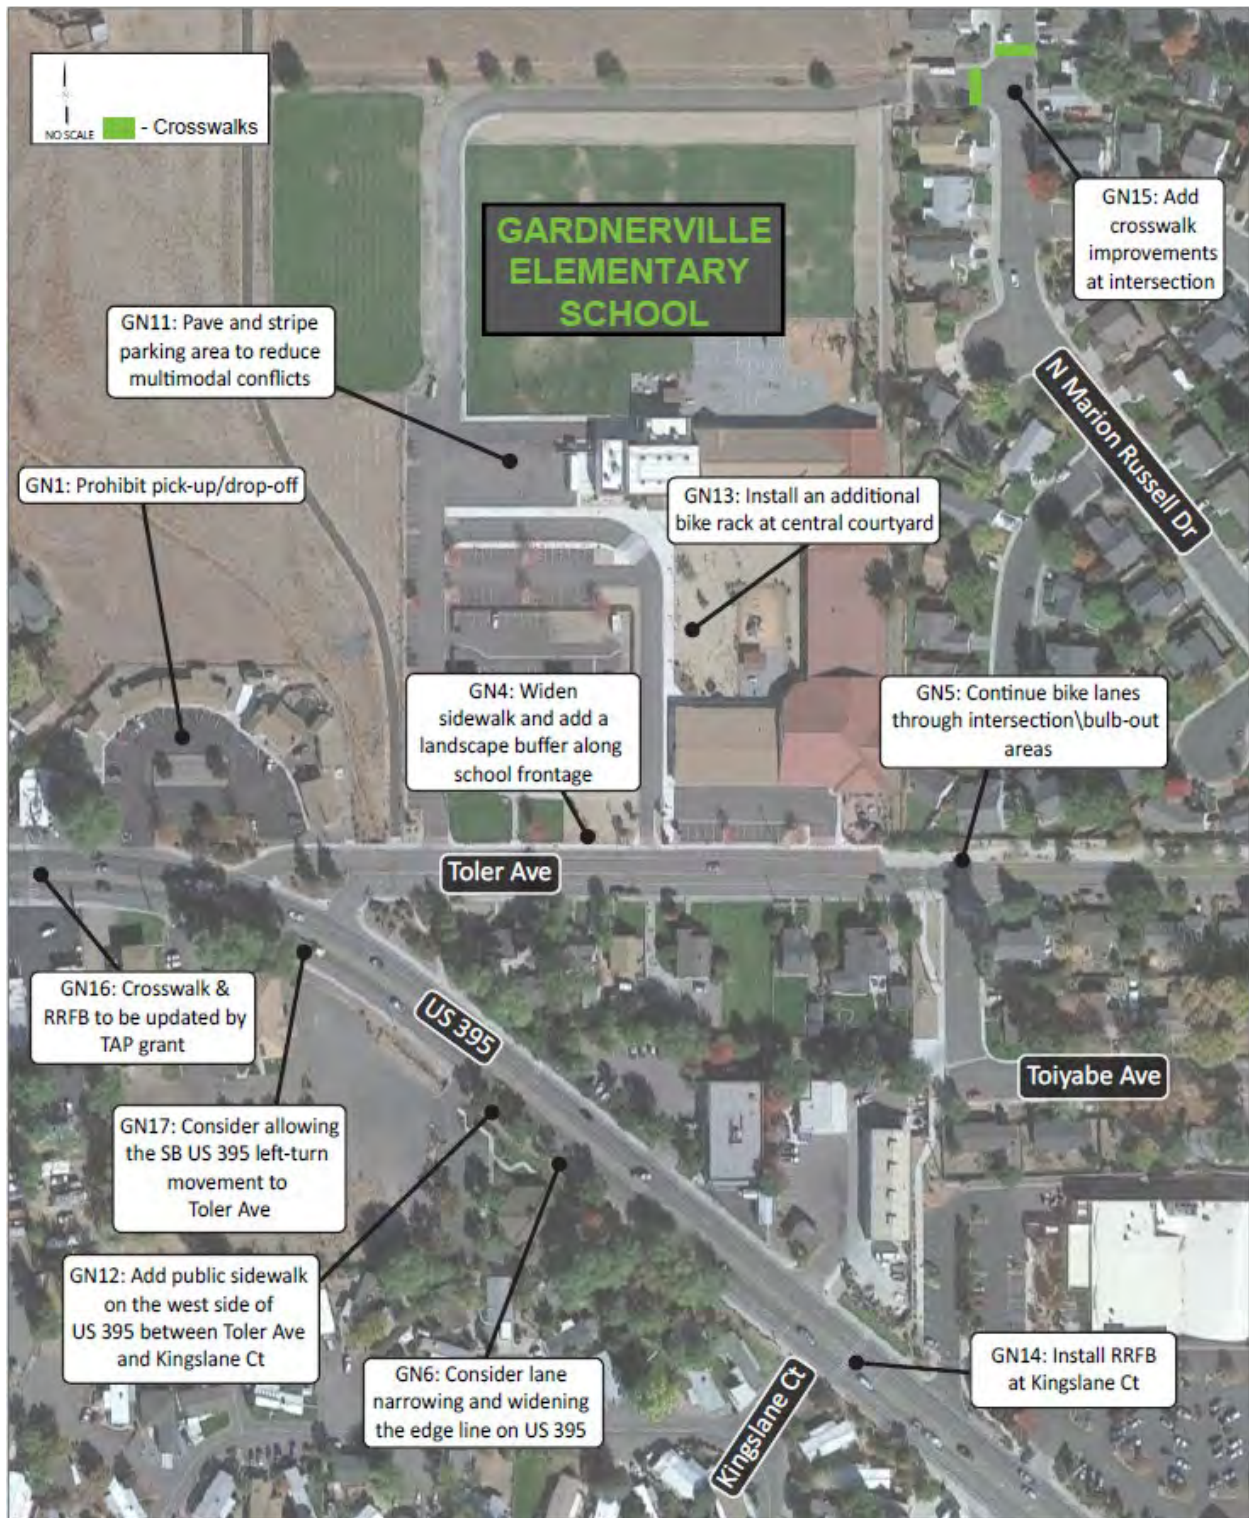
Exhibit D-2: Gardnerville Elementary School Recommended Improvements

Improvements to help alleviate access, circulation, and infrastructure issues/deficiencies found at Gardenville Elementary School are outlined in **Table D-1** and shown in **Exhibits D-2** and **D-3**.

ID	Implementation Timeline	Priority	Location	Draft Recommendations	Cost Estimate
GN1	Short	Low	Village Motel parking lot	Prohibit pick-up/drop-off through increased signage and communication with students' families.	\$
GN2	Short	High	US 395/ Mission Street intersection	Install high visibility crosswalk with ADA ramps across Mission Street.	\$\$
GN3	Mid	High	West of US 395/ Mission Street intersection	Install continuous sidewalk with ADA ramps along US 395, where there are currently gaps in the sidewalk network.	\$\$
GN4	Mid	Low	Toler Avenue along school frontage	Widen sidewalk and consider installing a landscape buffer between the travel lanes and sidewalk.	\$\$-\$\$\$
GN5	Mid	Medium	West of Toiyabe Avenue/Toler Avenue intersection	Install bike ramp on the curb extension at the existing crosswalk for the bike lane along Toler Avenue. Consider delineation of pedestrian and bicycle facilities through materials and linear detectable warning surfaces.	\$\$

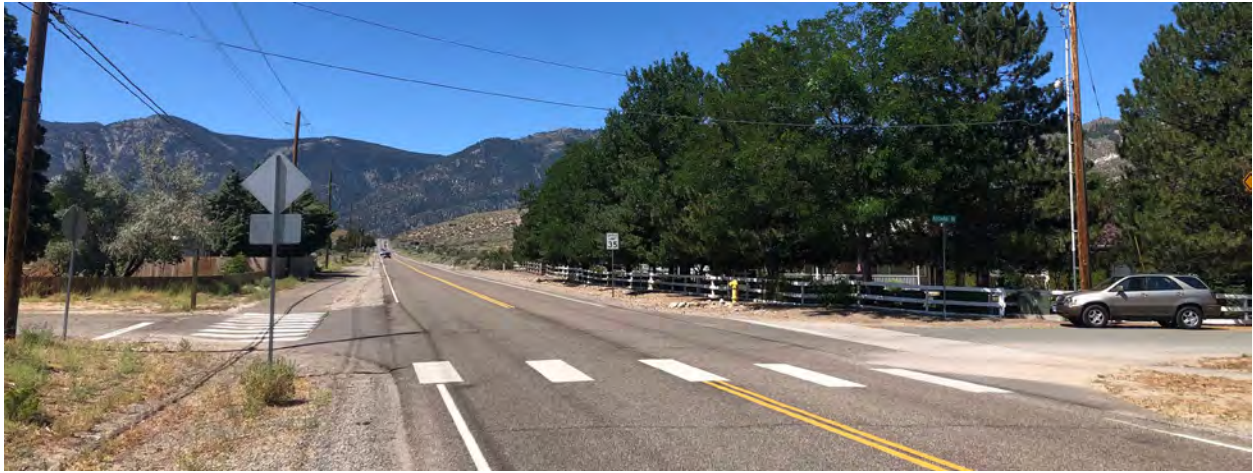
The multiuse path crossing at the intersection of Jacks Valley Road and Arcadia Drive was identified as a significant safety concern by Jacks Valley Elementary School. The current crosswalk is difficult to see and does not contain ADA accessible curb ramps. High travel speeds on Jacks Valley Road were cited as a major concern for parents in considering allowing their students to walk or bike to school. In addition, the current crosswalk is located on the side of the intersection that experiences the dominant travel demand pattern of vehicles travelling from Arcadia to US 395. A recommended improvement would relocate the crosswalk to the other side of the intersection, install overhead pedestrian activated RRFB, and construct ADA compliant curb ramps. A visualization is provided on the following page.

Existing conditions at Jacks Valley Road and Arcadia Drive

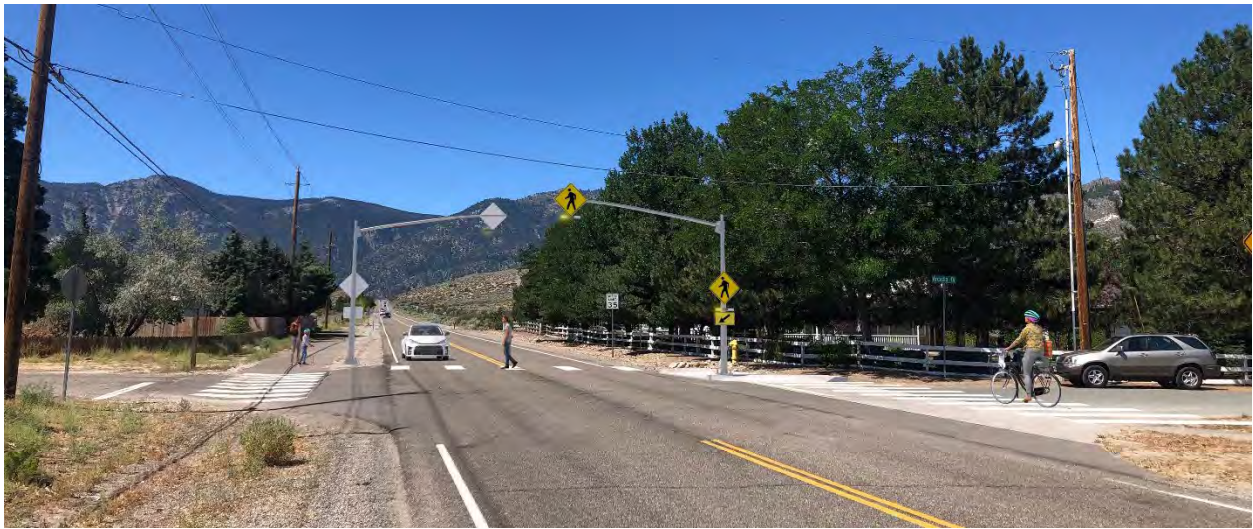
Proposed improvements along Jacks Valley Road and Arcadia Drive

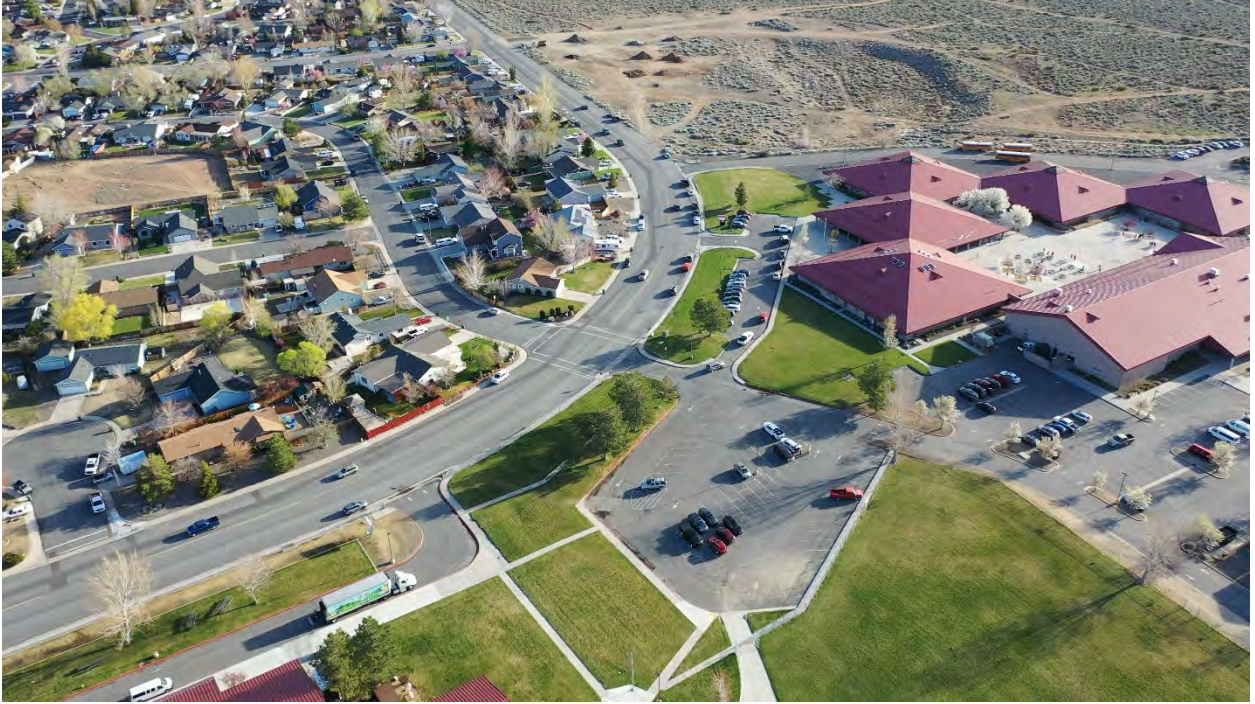
Existing conditions along Long Valley Road

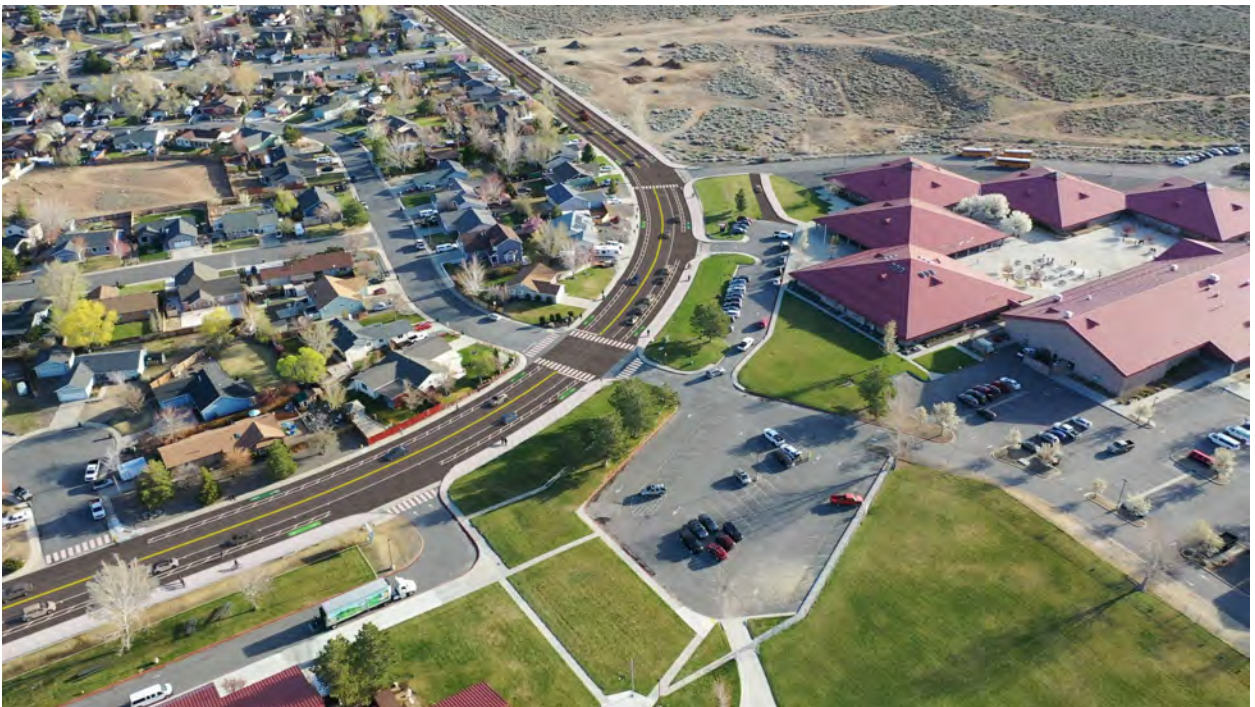
Project SC1 proposes restriping the existing roadway to include two 11-foot-wide travel lanes, 6.5-foot-wide bicycle lanes next to the curb, and parking lanes to provide a buffer between the bicycle lane and automobile travel lanes. Project SC5 proposes widening the sidewalks along the school frontage, removing barriers to the path of travel currently located in the sidewalk, and providing ADA accessible curb ramps.

Visualization of proposed improvements along Long Valley Road
